Specifying SPF Roofing Systems

Is a spray polyurethane foam system right for your next roofing project? Find out now.

By Mason Knowles

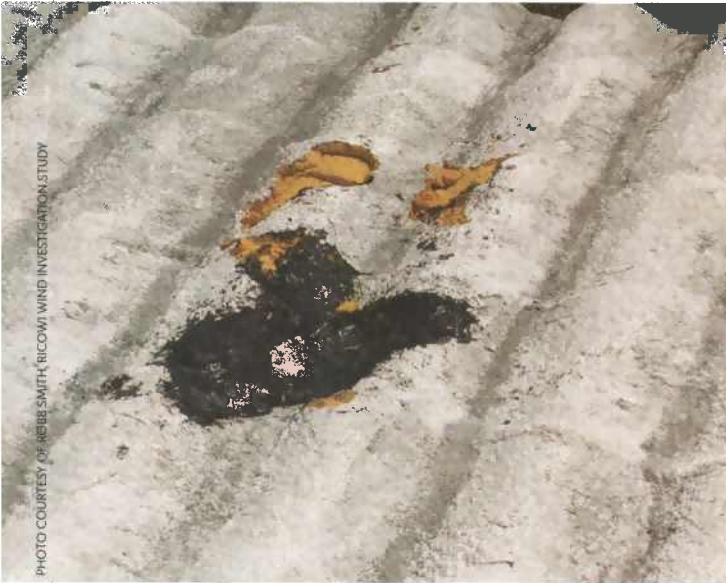
PHOTO COURTESY OF REBE SMITH, RICOWI WIND INVESTIGATION STUDY

Mechanical damage from wind-driven debris typically does not cause leaks in SPF roofing systems and can be repaired with a compatible sealant. This Pensacola, FL, roof survived a direct hit from Hurricane Ivan.

SPF roofing systems should be inspected semi-annually and after events that could cause mechanical damage, such as hail storms, tornados, and hurricanes. Small (less than 4-inch in diameter) cracks, gouges, or punctures can be repaired with an elastomeric sealant compatible with the SPF system. To repair more extensive damage, remove the damaged foam and reapply additional SPF and coating.

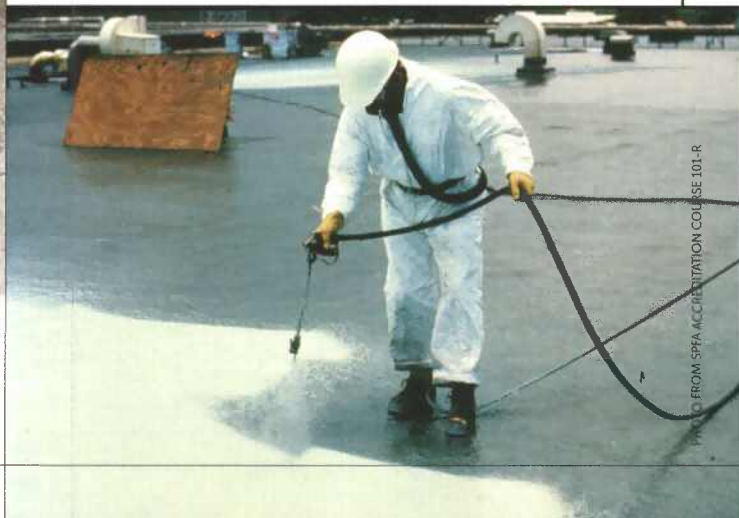
PHOTO FROM SFA ACCREDITATION COURSE 101-R

Applying elastomeric coating to SPF protects the foam from UV rays.

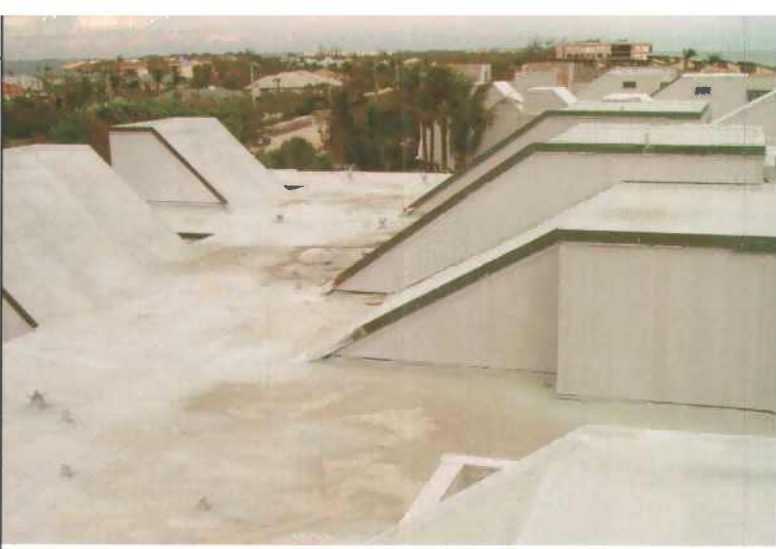
After direct hits from two severe hurricanes (Francis and Jeane) in Southern Florida, this SPF roof shows no damage from the storms.

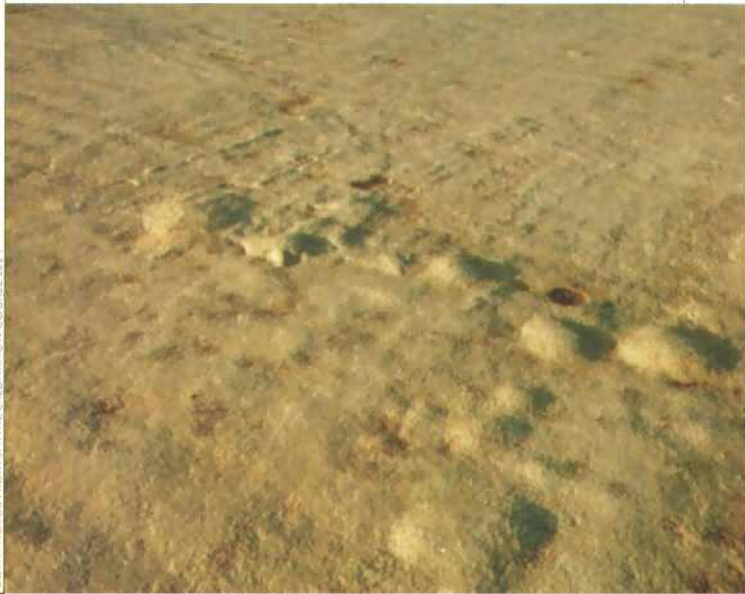
Above: Blisters on a SPF roof are typically caused by thin foam passes and/or moisture or contaminants on substrate. Left: Mechanical damage typically does not cause leaks in SPF roofing systems and can be repaired with a compatible sealant.

When incorrectly installed, SPF roofing systems often exhibit interlaminar blistering of the SPF layers. Foam blisters most often occur by trying to stretch the application window, improper substrate preparation, or equipment problems.

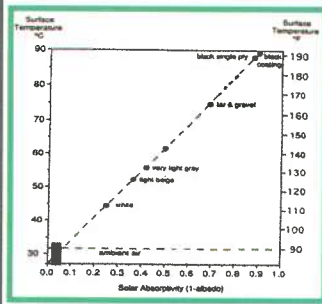
SOLAR ABSORBTIVITY

Solar Absorbtivity vs. Surface Temperature of Horizontal Surfaces: paints, roofing materials, roadways and cities, adjusted to noon on a clear, windless summer day in Austin, TX.
